1. CLAIM & VEHICLE DETAILS

| Insurance Claim Summary | | Vehicle Identification | |
|---|---|---|---|
| Insurance Carrier: | Example Insurance Co. | Year / Make / Model: | 2019 Cadillac XT4 Sport |
| RO Number: | SAMPLE-1001 | Operation: | Bumper R&I, windshield replace |

4. CALIBRATION EXECUTION & ROAD TEST VALIDATION

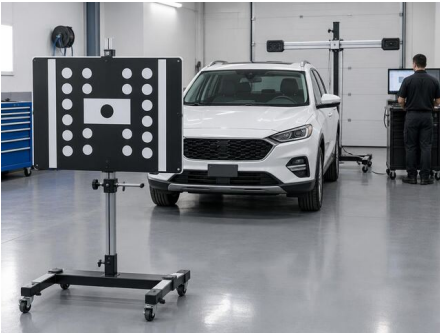
Camera target setup  
40.7128, -74.0060  
9/15/2026, 2:30:00 PM

| System Calibrated | Calibration Method | Target Reference / Distance | Post-Scan Result | Status |
|---|---|---|---|---|
| Forward-facing camera static calibration | Static Alignment | OEM target board @ 1,500 mm | DTC Clear (0 Codes) | PASS |

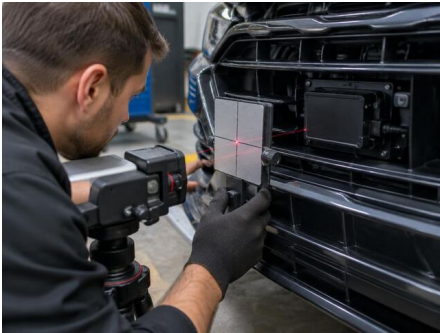
Radar aim verification  
40.7128, -74.0060  
9/15/2026, 2:30:00 PM

| System Calibrated | Calibration Method | Target Reference / Distance | Post-Scan Result | Status |
|---|---|---|---|---|
| Front radar (long-range) alignment | Static + Dynamic | Radar reflector @ 1,000 mm | DTC Clear (0 Codes) | PASS |

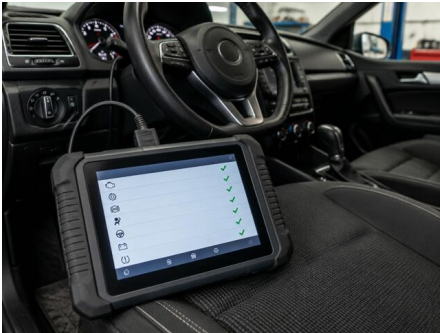
Post-calibration scan screen  
40.7128, -74.0060  
9/15/2026, 2:30:00 PM

| System Calibrated | Calibration Method | Target Reference / Distance | Post-Scan Result | Status |
|---|---|---|---|---|
| Pre- and post-repair diagnostic scan | OEM Scan Tool | GM GDS2 | DTC Clear (0 Codes) | PASS |
